Another Case for Coating

Jerry Petersheim and T. Page McAndrew, Ph.D., Arkema Inc.
Paul Maier, Monroe County Water Authority

Check out the impressive results reported from this efficiency improvement study of a horizontal split-case pump repaired and coated with Polyamide-11 based powder coatings.

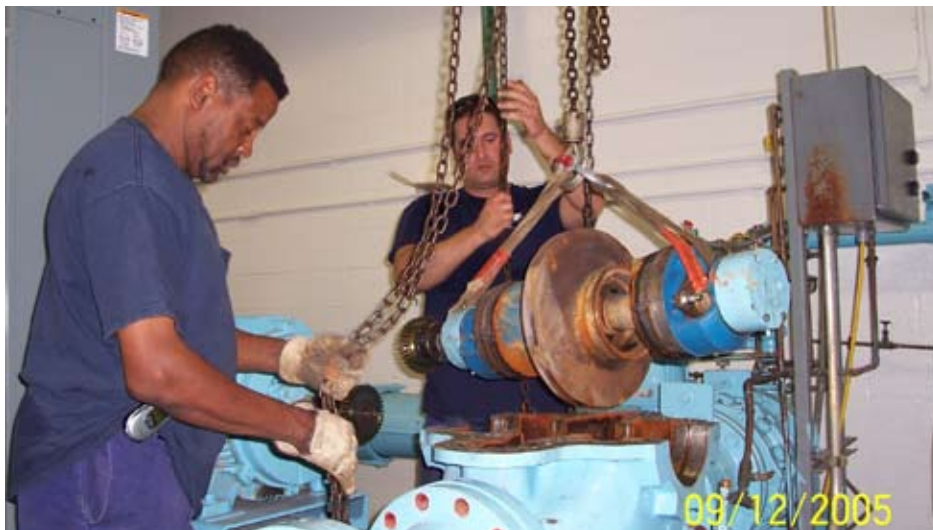
Figure 1. Denise No. 2 horizontal split-case pump being taken out of service for repair and coating.

the pump housing and impeller with a polyamide 11-based powder coating. Figure 1 shows the Denise No. 2 being taken out of service.

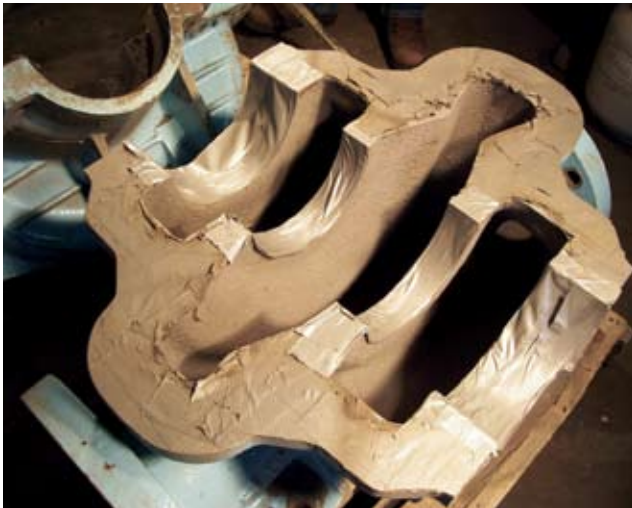
Figure 5. Denise No. 2 horizontal split-case pump – lower half of pump housing after masking the seal areas and grit blast cleaning. A thin dry-film thickness of 0.2 to 0.5-mils (thousandths of an inch) was targeted. After the primer dried about ten minutes, the housing was placed into a convection oven maintained at 525-deg F for one hour. The time and temperature allowed the casting to reach a metal temperature well above the melting point of the RILSAN® Fine Powder grade 625 BLACK MAC ES (melting point of polyamide-11 is 367-deg F).

Both sections of the pump housing were cleaned at Miller Sandblasting and Painting (Rochester, NY). The exterior and interior of the castings were manually abrasive grit blast cleaned to an SSPC-SP5 white metal finish with a 2 to 4-mil surface profile. Grit employed was Beauty 3535. Figures 5 and 6 show the results of the grit blast cleaning.

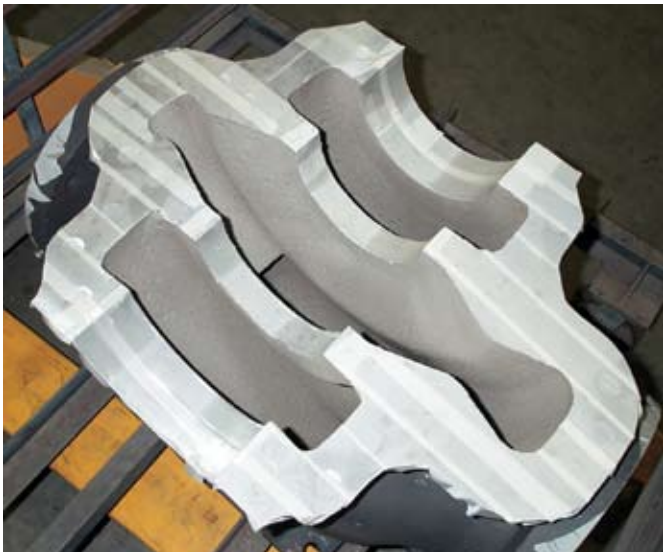
Figure 7. Denise No. 2 horizontal split-case pump – lower half of pump housing after stainless steel plasma coating.

The first stage was to mask the bearing and seal surfaces to protect them from being coated. After the masking process, Swain applied a stainless steel plasma coating onto the interior surfaces. The purpose of this coating was to fill in the large voids caused by the severe corrosion and to provide a good surface profile for the polyamide-11 powder coating to adhere to. Photos of the housing parts after the stainless steel coating are shown in Figures 7 and 8.

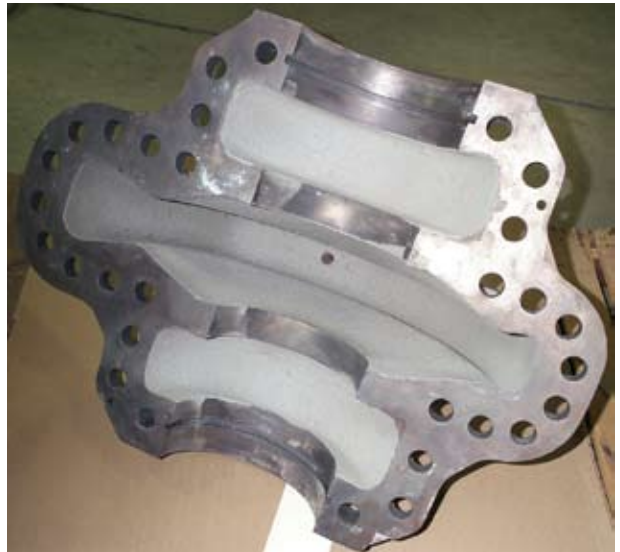
Figure 8. Denise No. 2 horizontal split-case pump – upper half of pump housing after stainless steel plasma coating.

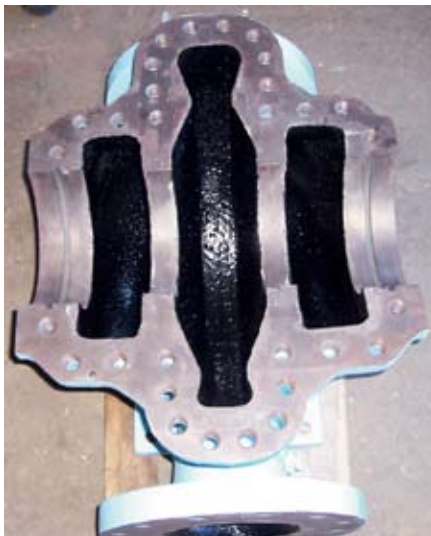
Figure 9. Denise No. 2 horizontal split-case pump – lower half of pump housing after the application of RILSAN® Fine Powder.

After the preheat stage, the housings were removed from the oven, one half at a time, and the RILSAN® Fine Powder was immediately manually sprayed onto the interior of the housing using electrostatic powder spray equipment. The application of spraying powder onto a hot metal part is called a *hot-spray*, or *hot-flock*, application.

Upon contact with the hot metal, the thermoplastic powder melted and flowed, forming a continuous coating film on the entire interior surface. A film thickness of 12-15 mils was targeted. After air-cooling, the molten polyamide coating

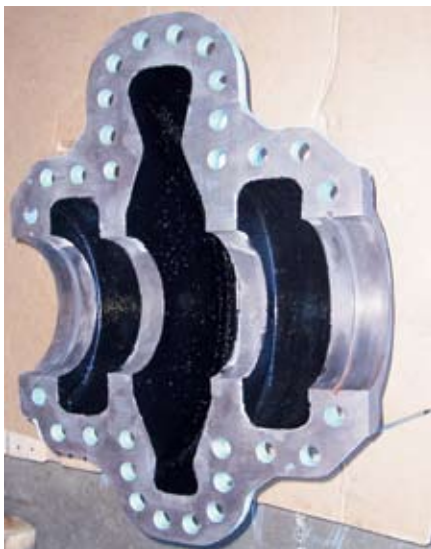
Figure 10 – Denise No. 2 horizontal split-case pump – upper half of pump housing after the application of RILSAN® Fine Powder.

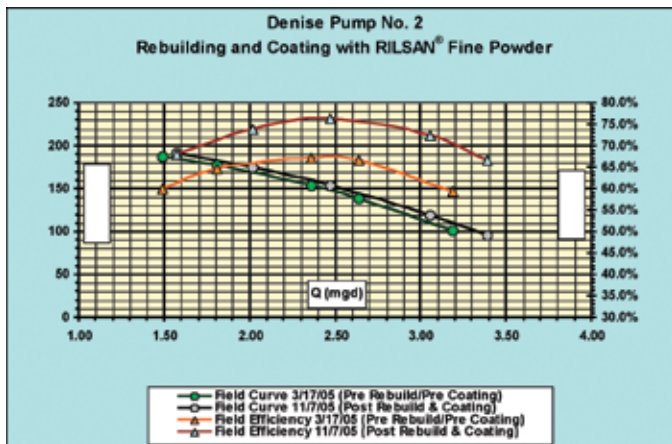
Figure 14. Efficiency measurement data of Denise No. 2 pump prior to mechanical repairs and after repairs.

MCWA reassembled the Denise No 2 pump after the housing and impeller were repaired and coated with RILSAN® Fine Powder, and efficiency data was measured. The results of the mechanical repairs and coating with RILSAN® Fine Powder yielded a total increase in efficiency of 10 percent as shown in Figure 14.

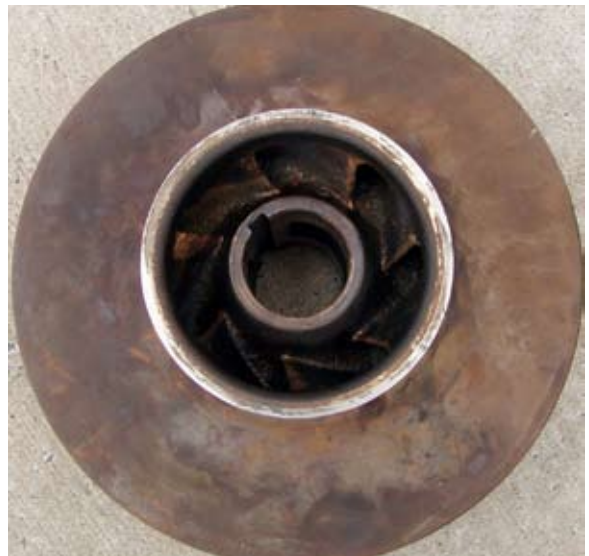
Figure 11. Denise No. 2 impeller prior to the coating process.

The ideal method for powder coating the pump impeller is the *fluidized bed method* so an even, uniform coating can be applied on all surfaces of the impeller. The preparation and coating of the impeller was completed by Arkema, Inc. (King of Prussia, PA). The condition of the impeller is illustrated in Figure 11.

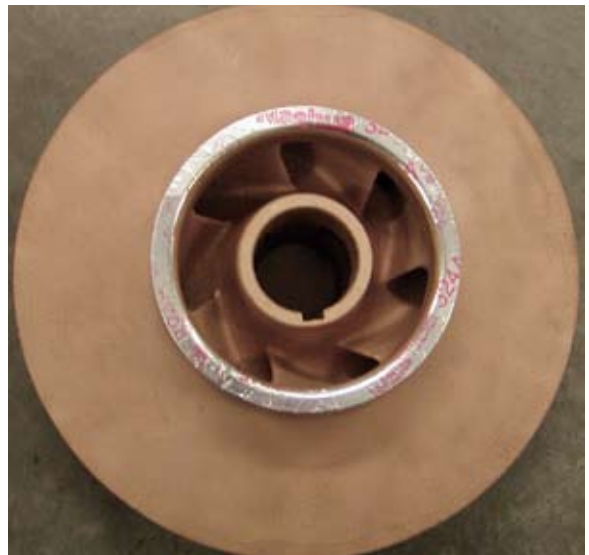
Figure 12 -Denise No. 2 impeller prior to the coating process.

- The areas not to be coated were masked with aluminum duct/ventilation tape. The photo in Figure 12 shows the condition of the impeller after abrasive blast cleaning and masking.
- A 50:50 mixture of RILPRIM™ P23V40 primer and methyl ethyl ketone was applied by squeeze bottle (note there were a large number of hidden areas and crevices – a diluted solution was used to prevent the primer layer from being too thick). A dry-film thickness of 0.2 to 0.5 mils was targeted. The primed part was air-dried for 15 minutes.
- The impeller was placed in a pre-heated oven maintained at 550-deg F for a time of 40 minutes. This brought the metal temperature to about 450-deg F.

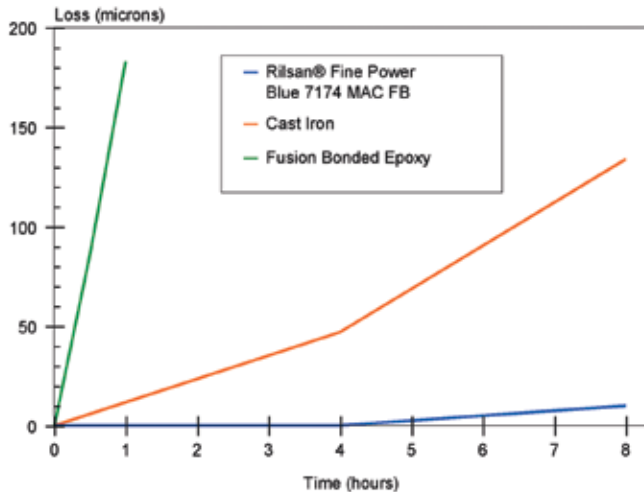
Figure 15. Cavitation Erosion Test Results of Rilsan® Fine Power, cast iron, and Fusion Bonded Epoxy.

A raw water sample was taken from MCWA's inlet from Lake Ontario. The turbidity and pH of the raw water was measured to be 8.0 and 8.8, respectively. This water was collected to measure cavitation erosion properties of uncoated cast iron, RILSAN® Fine Powder coated metal substrate, and fusion-bonded epoxy coated metal substrate according to ASTM G32, Cavitation Erosion Using Vibratory Apparatus.

The results of cavitation erosion are reported in Figure 15, which shows that the RILSAN® Fine Powder coating outperformed the fusion-bonded epoxy by 175X and the cast iron by 10X.
